# ETUI Seminar – Improving Machinery Safety

# Fatal accidents on treatment tables

# Quick couplers on earth-moving machinery

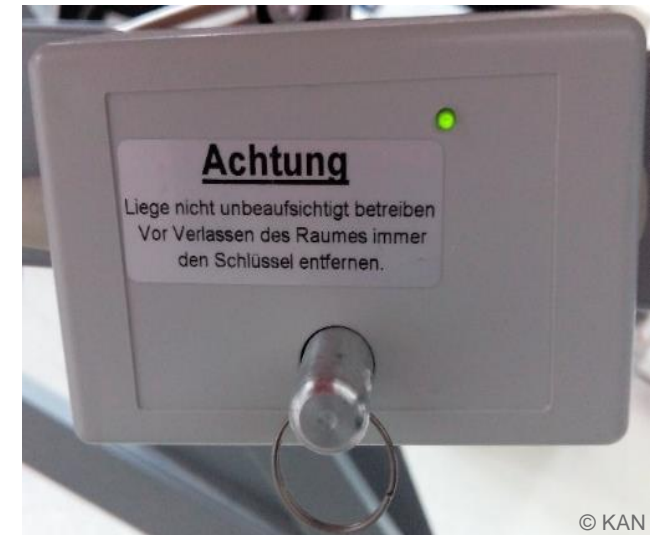
- 2016/2017 **fatal accidents** to employees
- further accidents with children, users and patients are known
- currently **no standard exists for treatment tables**
- in Germany: “locking box”  
(a rather organizational measure)

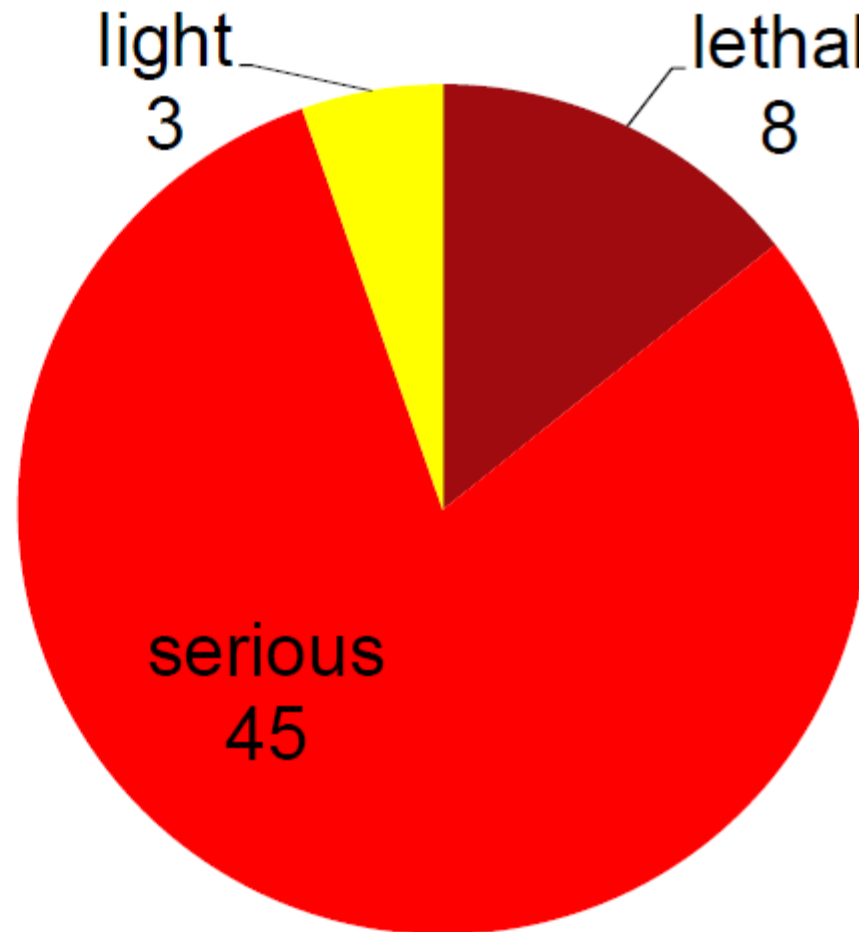
# BG BAU: Accidents with quick couplers 2010... June 2018

absolute: 56

## Reasons for accidents:

- Not engaged correct
- Not engaged
- technical fault
